Solicitation No: IFB 21-01-22

Description: High School Gym Roof Replacement Project

Amendment No.: One (1)

BUILDING #1013 (GYMNASIUM)

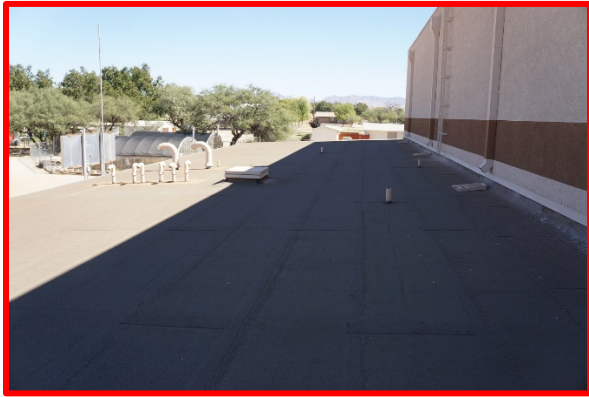
Overview of lower elevation low-slope bituminous roof system.

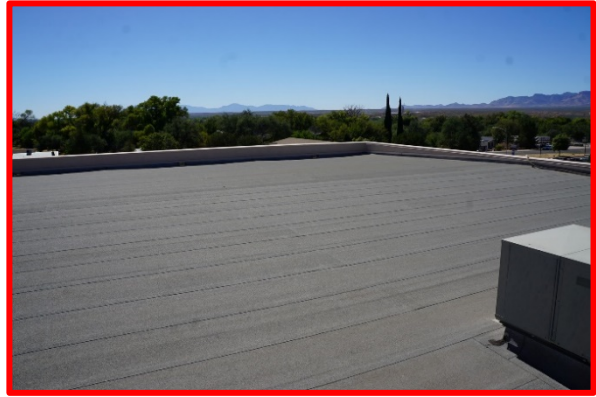
Overview of upper elevation low-slope Bituminous roof system.

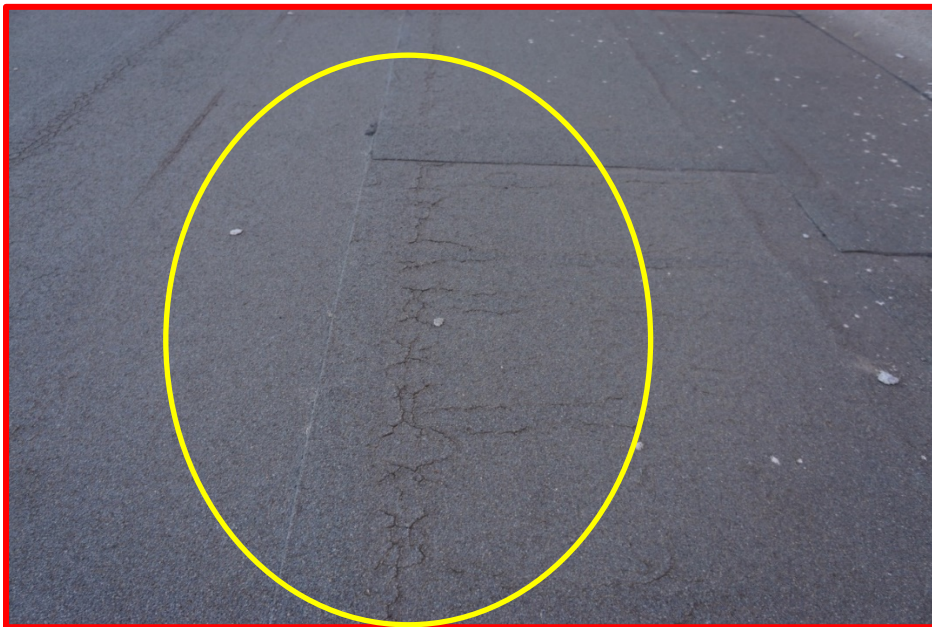
Lower roof cap sheet is alligatoring¹ and cracking, most likely due to UV exposure.

¹ Alligatoring is a characteristic in asphalt, which occurs during aging. Exposed asphalt inherently over time loses volatile oils; in conjunction with oxidation caused by UV exposure creates a pattern of cracks. These cracks resemble alligator hide.

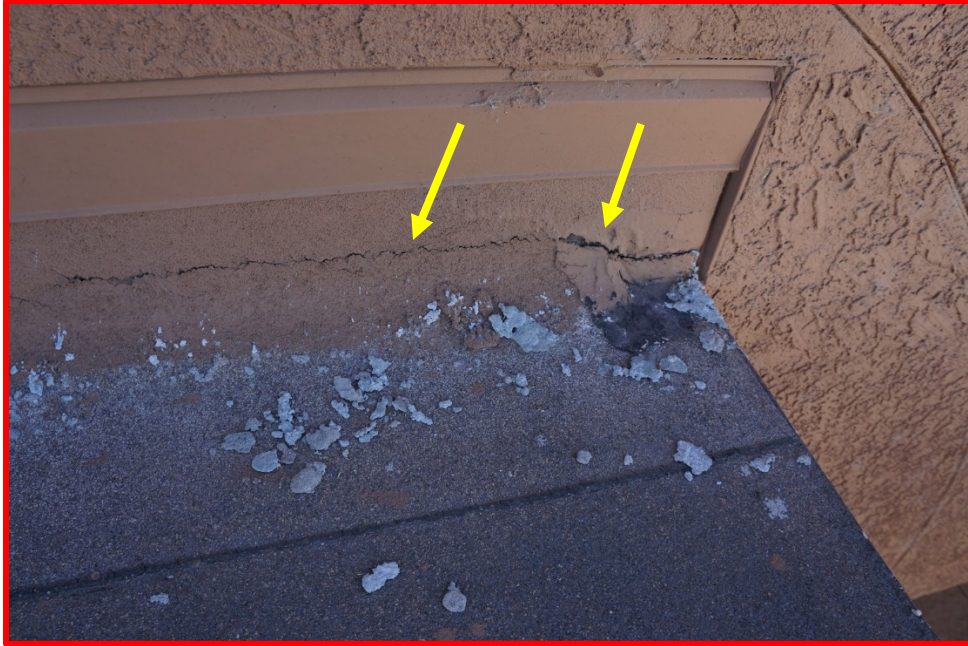
Cracked and torn roof cap sheet as indicated by the yellow arrow in the photograph above. This condition is allowing moisture into the interior of the building.

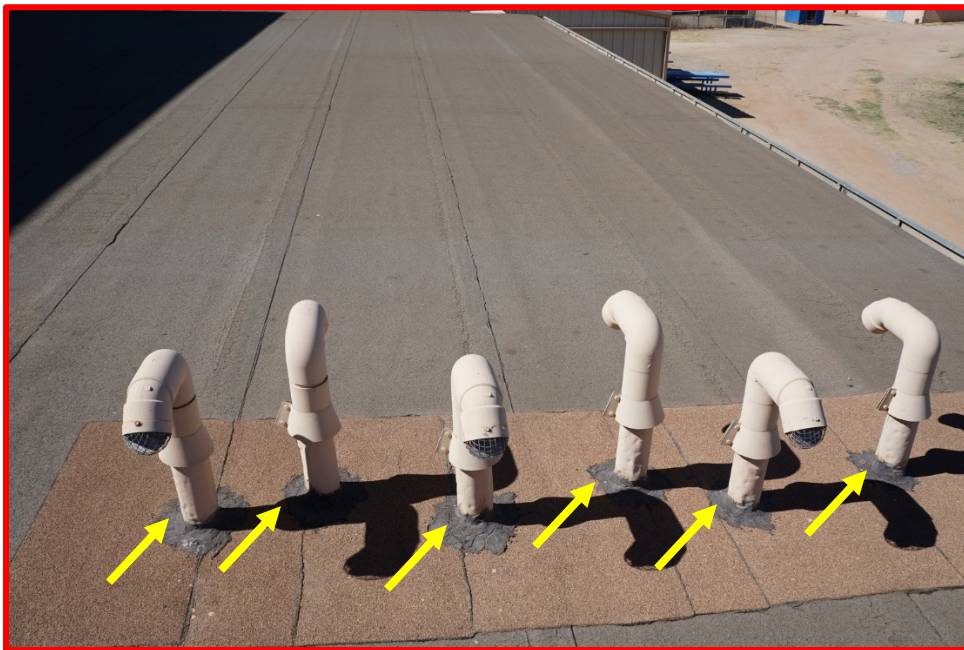
Improper flashed repair at the roof penetrations on lower deck. Roof repair plastic (also called “roofing bull” or “roof mastic”) as identified by the yellow arrow has deteriorated and cracked no longer performing as intended. This condition is allowing moisture into the roof system.

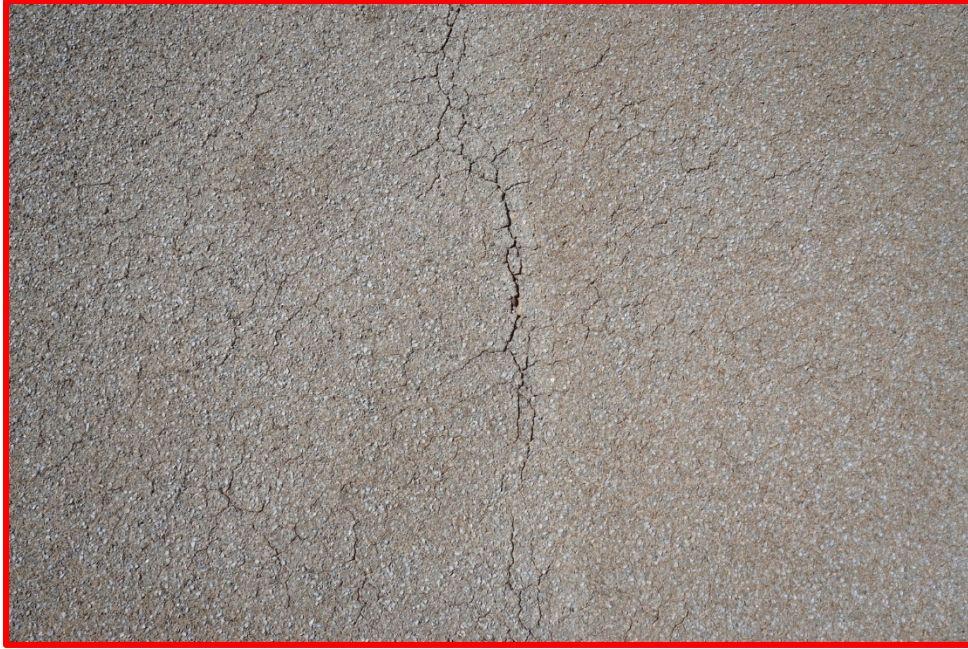
Upper roof cap sheet is alligatoring and cracking, most likely due to UV exposure. This condition is allowing moisture into the roof system and most likely into the interior of the building below.

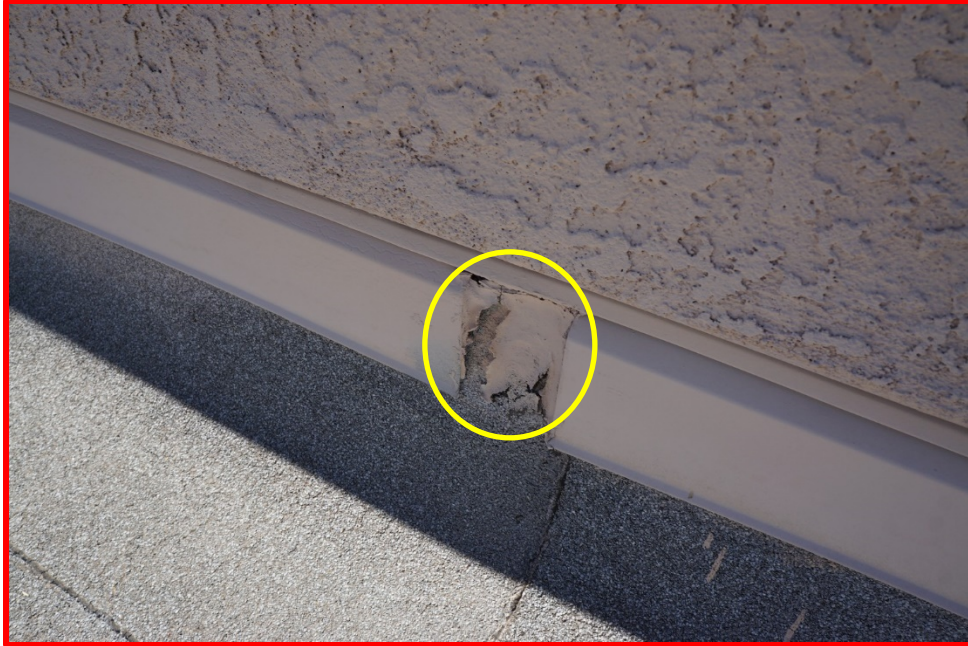
Missing reglet flashing for roof termination. Roof repair plastic (also called “roofing bull” or “roof mastic”) as identified by the yellow arrow has deteriorated and cracked no longer performing as intended. This condition is allowing moisture into the roof system.

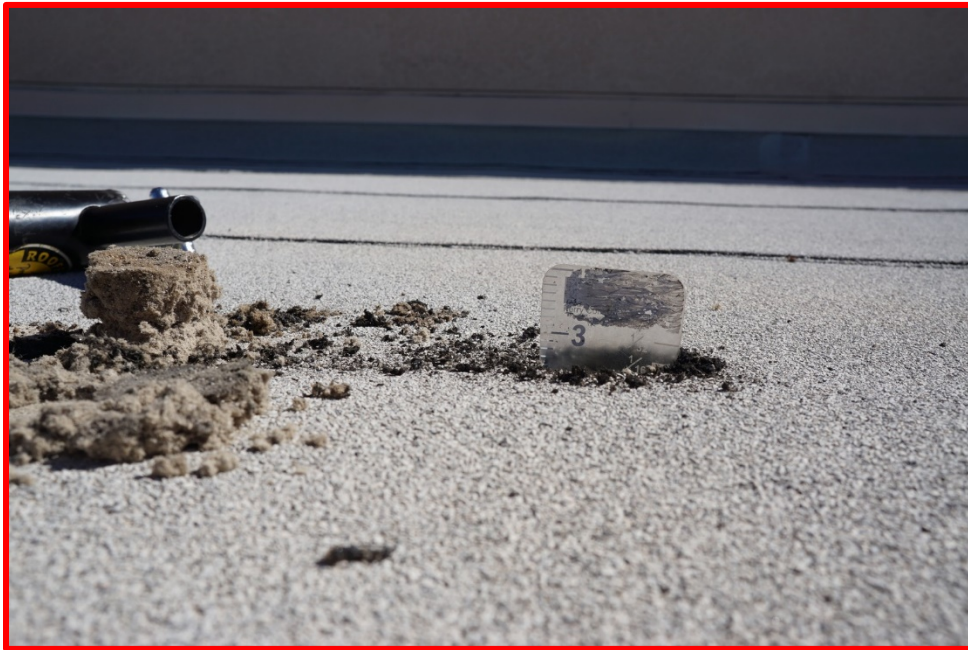
Overview of the roof sample core at the low-slope bituminous roofing system.
